**NATIONAL REGISTER OF HISTORIC PLACES
REGISTRATION FORM**

historic name Orendorff, John, Farm

other names/site number CARR-1425

CARR-1425
Orendorff, John, Farm
Carroll County, MD

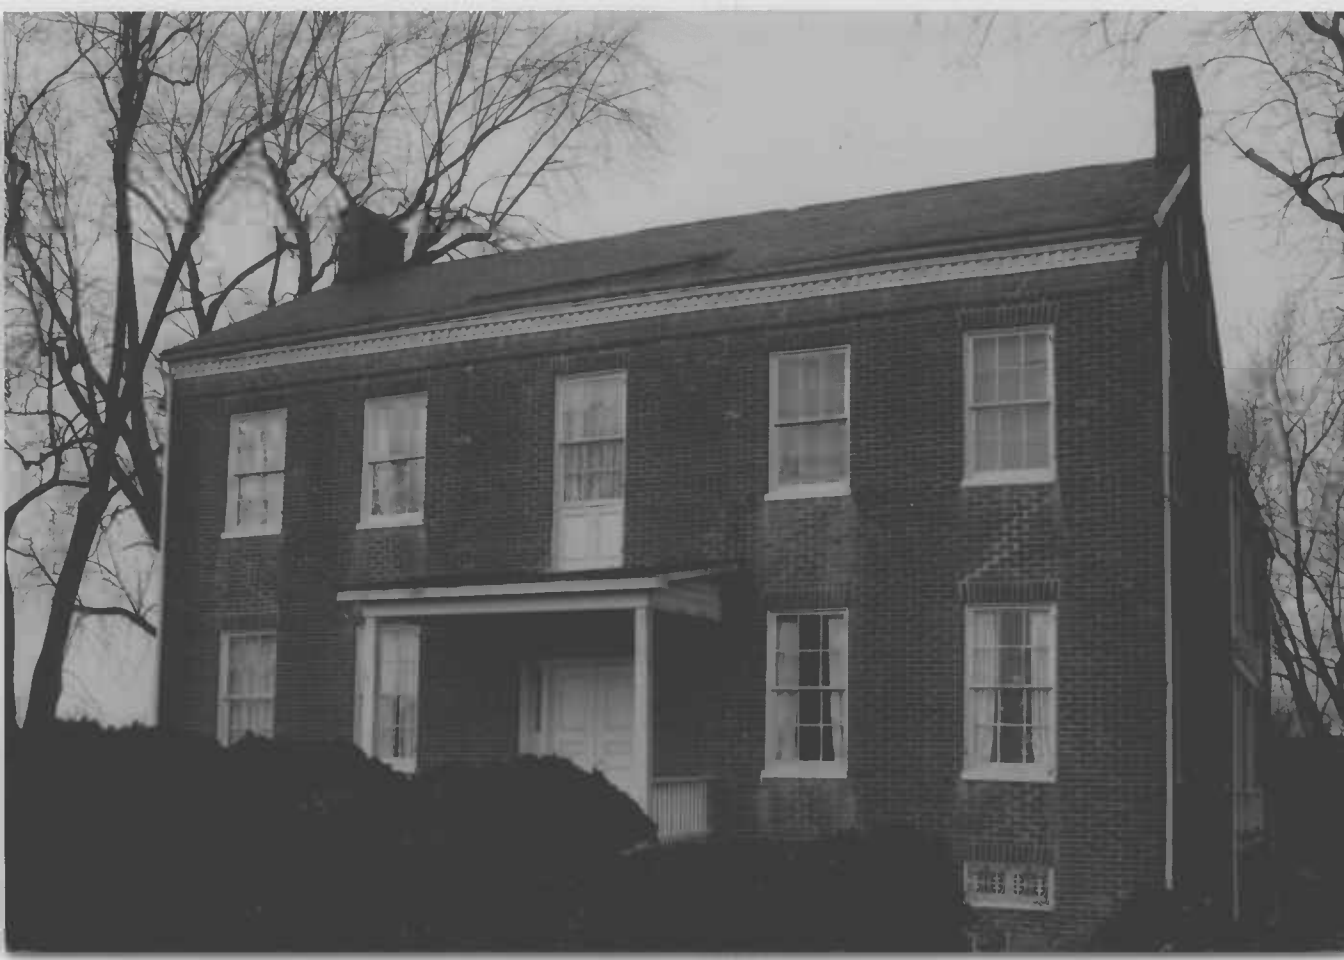
Neg. Loc. Maryland Historical Trust
House - South elev.

The house faces south and is a five-bay by two-bay brick structure with a six-bay by two-bay brick ell on the north elevation. The ell is 2½ stories tall. The house has a rubble stone foundation, brick walls, and a gable roof of slate with a ridge that runs east-west on the main block, and a ridge that runs north-south on the ell. The house is banked on the west with an exposed foundation on the east. The south elevation foundation has a two-light casement window with a wood sill, a splayed brick jack arch, a beaded-interior-edge frame, and a cast

iron grill with a fleur de lis in the four end bays. The center bay has a brick porch foundation that is not tied into the house. The first and second stories have running bond. The first story has a center entrance with paired doors. Each half has three panels, with a lying panel in the center and a square panel at the bottom. There are sidelights with two lights over two panels. These panels line up with the door panels. There is also a six-light transom. The transom bar is fluted, as are the sidelight stiles. There is a marble sill and a bullnose frame. There is a one-story, one-bay porch with two square posts that have square-in-plan balusters on each side of the porch. The porch has a wood box cornice and an inverted-V-seam metal shed roof. There are two 6/6 double-hung sash on each side of the door. They each have a wood sill, a splayed brick jack arch, and a bullnose frame. They had blinds with cast iron shell-pattern shutter holdfasts. The sash are pegged. The second story has four shorter 6/6 sash. The center bay has a typical 6/6 sash with a jib window that has two one-panel doors below the sash. The brick cornice has a projecting brick frieze and brick dentils with three corbelled courses above. There is an interior brick chimney on each end, centered on the gable ridge.

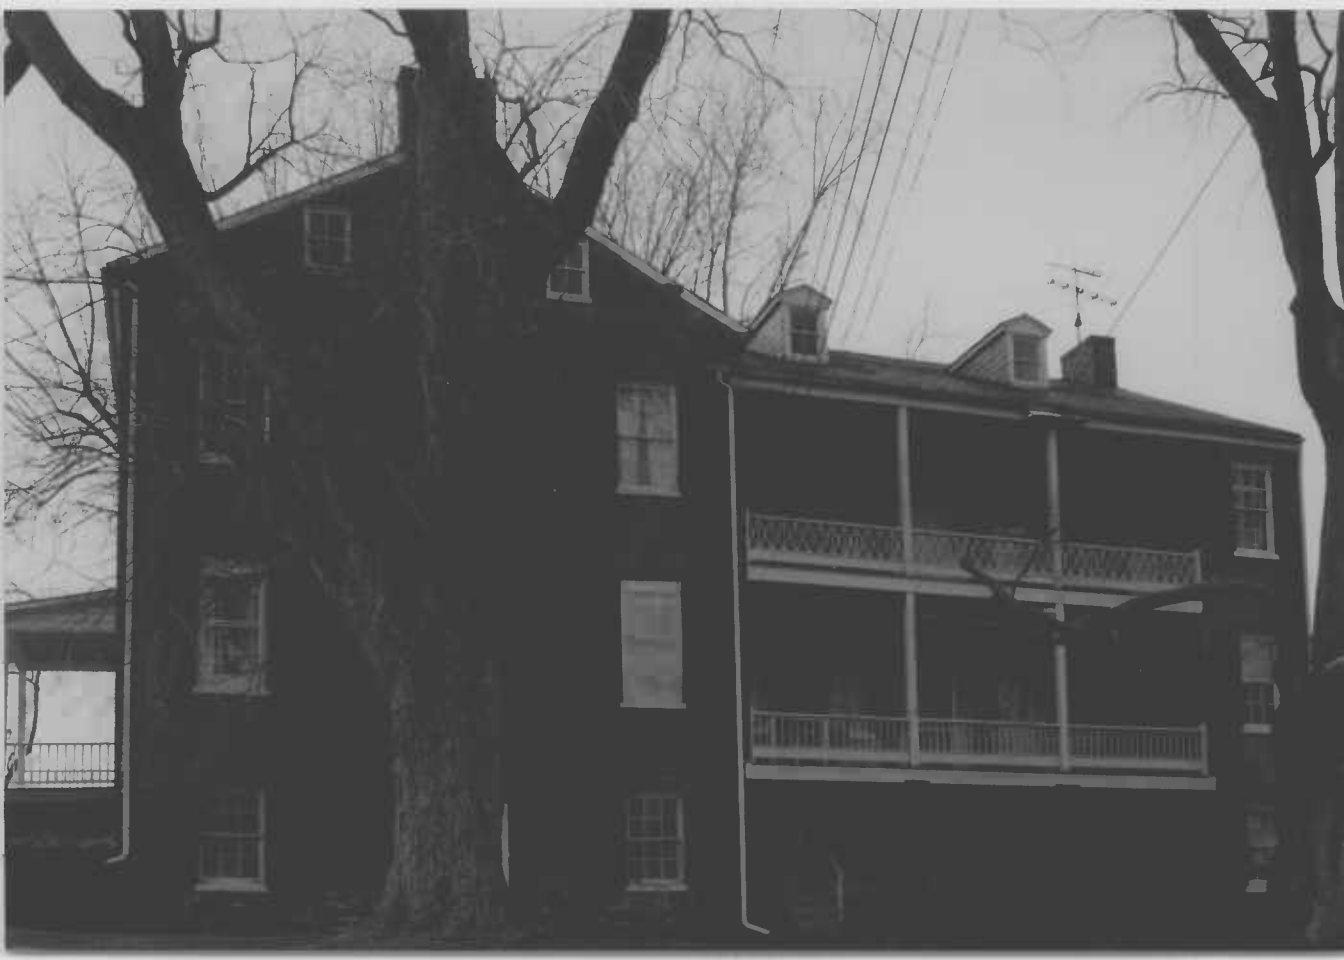
Meg. Loc. Maryland Historical Trust
House - east elev.

The east elevation foundation has roughly coursed partly dressed stone. The main block has two typical 6/6 sash in the foundation, with a typical six-panel door in the center. It has a beaded interior edge frame, as do the windows. The first and second stories both have two typical 6/6 sash. The gable end has two typical 2/2 sash with no jack arches. In the center of the gable end is a stone plaque with "JOHN ORENDORFF A.D. 1861". There are insulators down the center of this elevation.

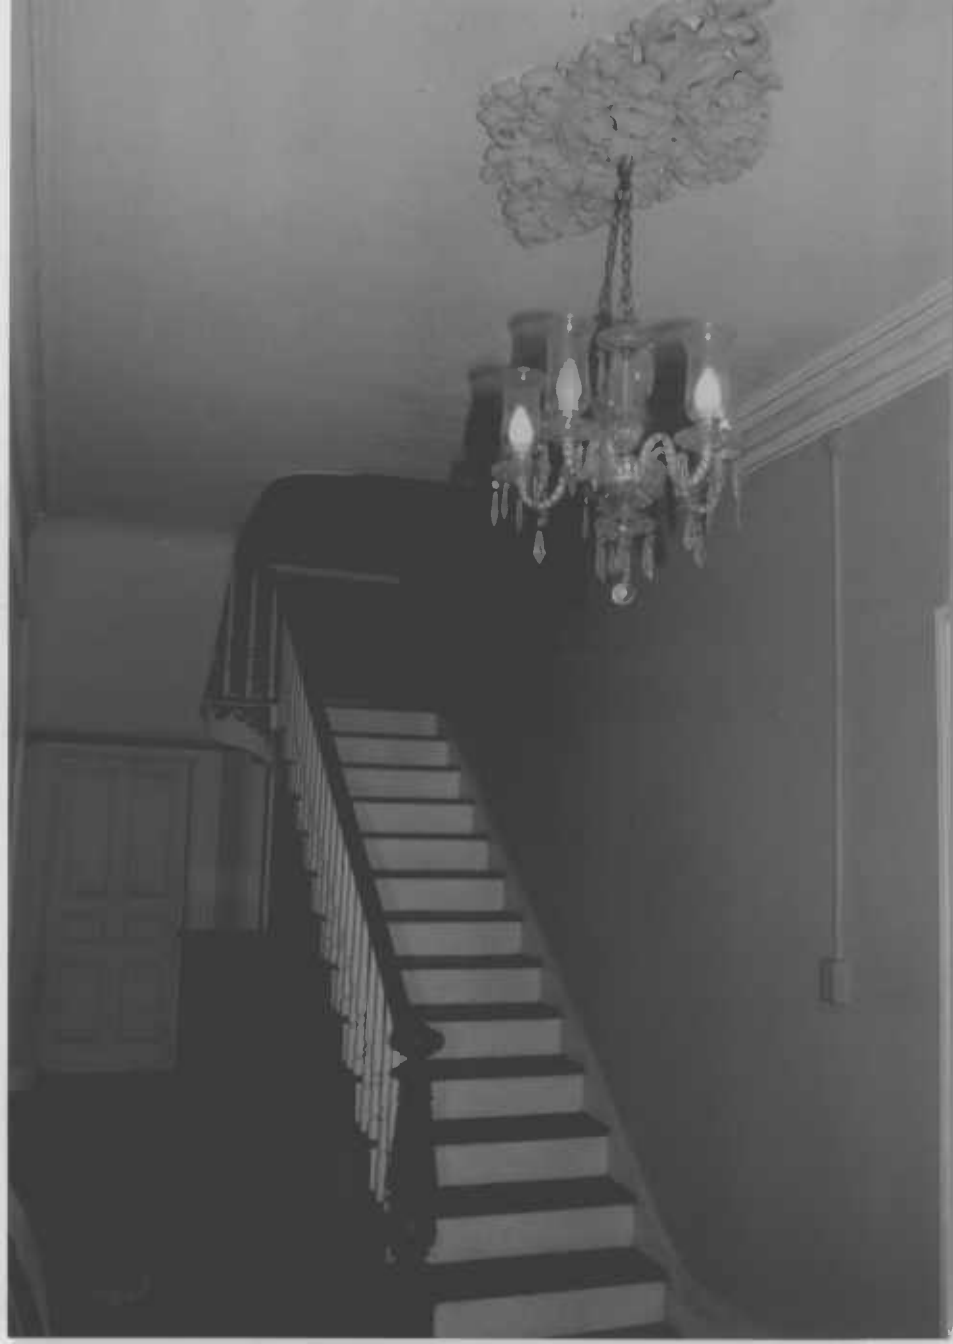
center passage - 1st Story - View north

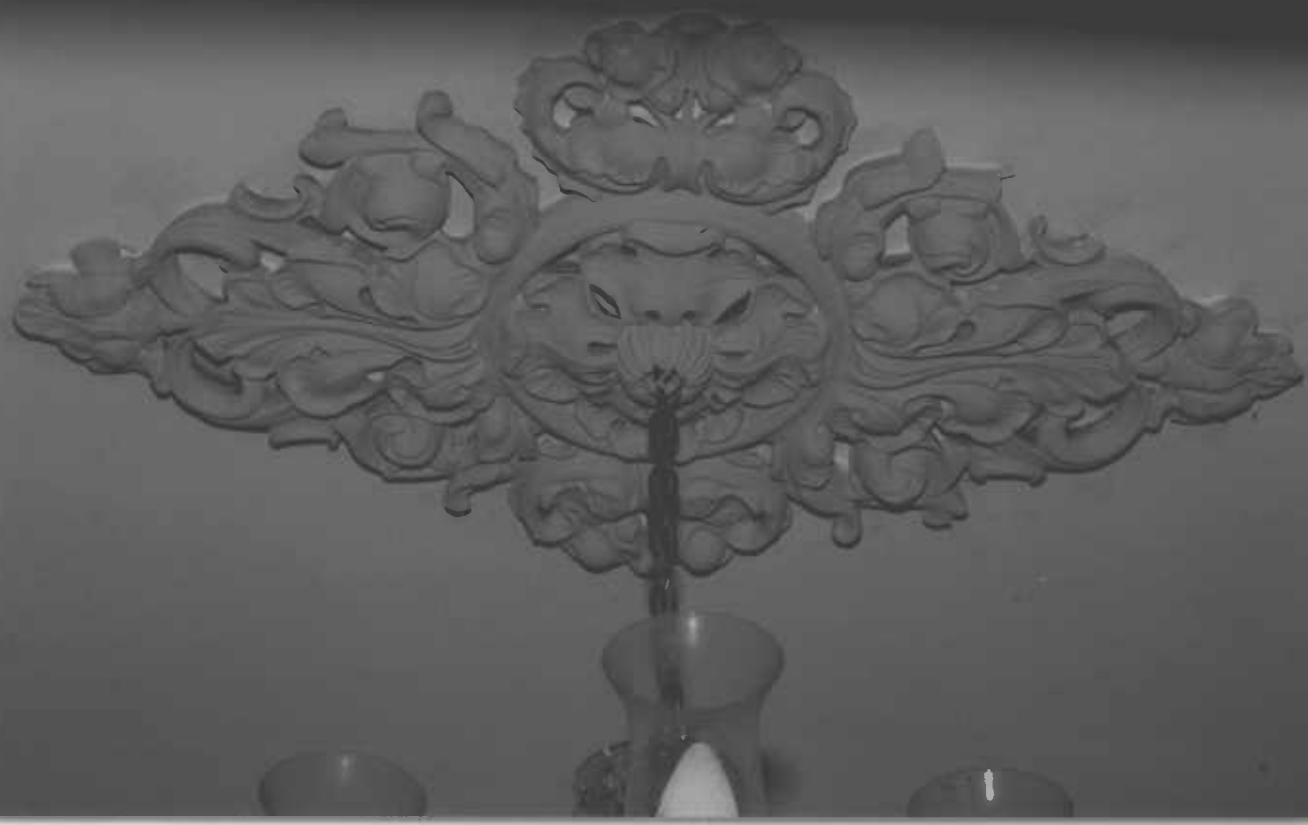
Neg. Loc.: Maryland Historical Trust
center passage-ceiling

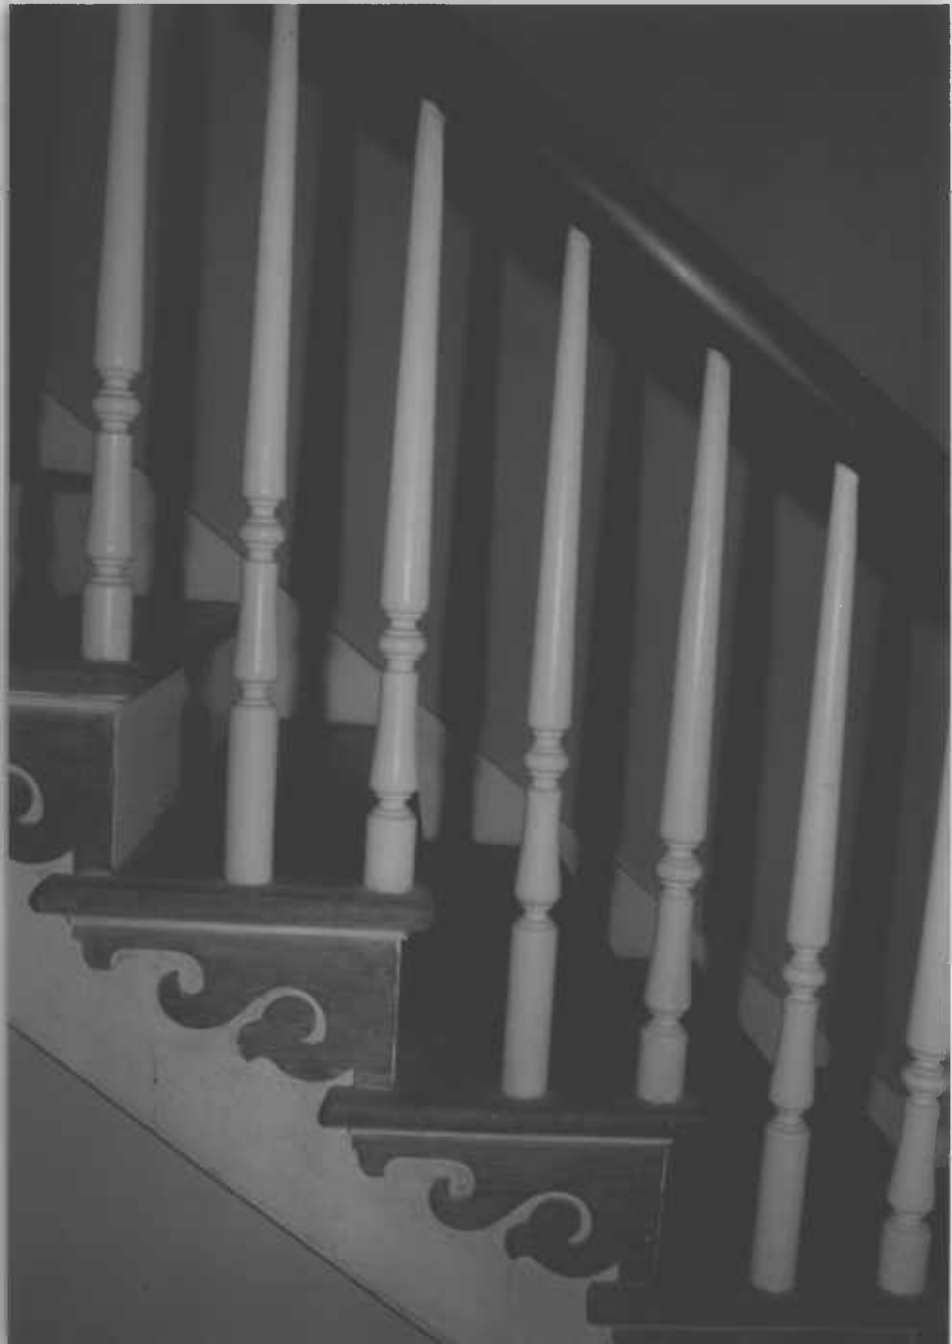
Stair detail

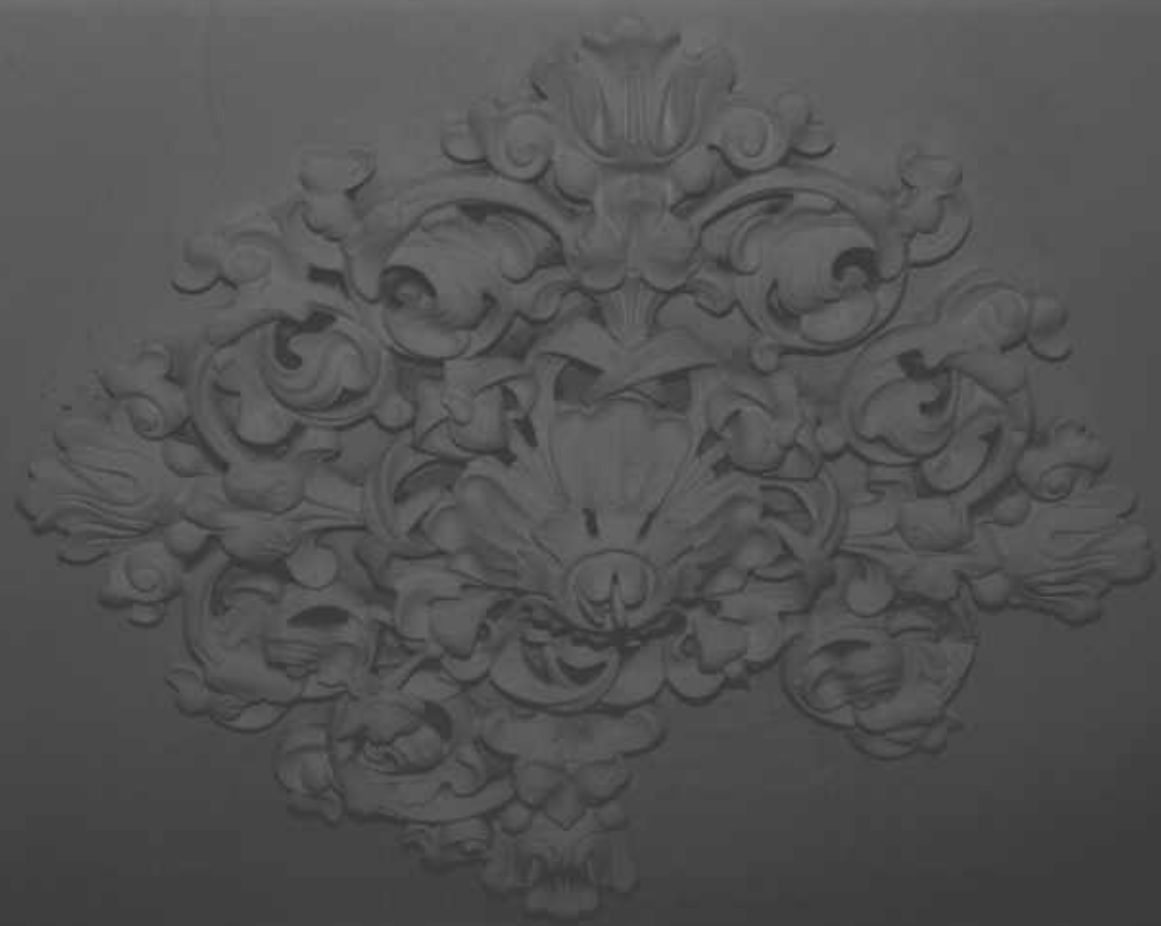
Neg. Loc.: Maryland Historical Trust
west room ceiling medallion

The west room is one large room with 5½ to 6-¾ inch wide, random-width flooring that runs north-south. The baseboard, architrave, doors, and cornice all are identical to the passage. This room also has a plaster band on the ceiling that has a torus flanked by a cavetto on either side. In the center of the room, running east-west, is a beam that may or may not be structural. The soffit has the same plaster band as is found on the ceiling, done to create two panels. Each end of the beam has a plaster bracket. It has a volute with an acanthus leaf under it and two rosettes on it. There is a Greek cavetto and ovolo above the volutes. The west wall has two identical fireplaces that have slightly splayed plastered jambs and a brick hearth. They have a wood mantel with plain pilaster strips and a plain frieze that has a segmental, depressed arch. There is a bevelled bed mould and a plain shelf. The window jambs are splayed, and there is one panel underneath each window that has a recessed field and a quirked Greek

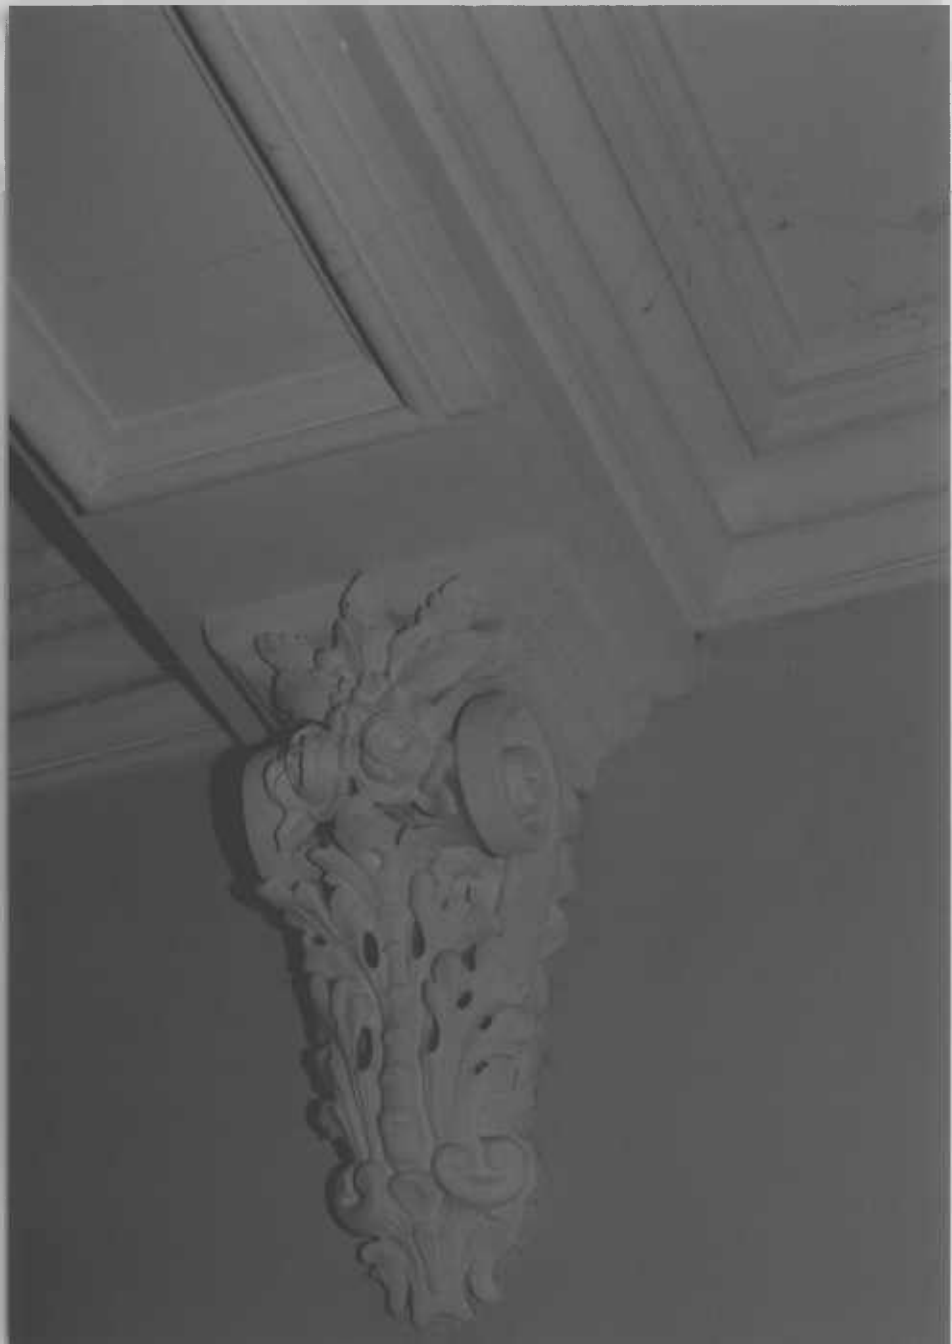
Neg. Loc.: Maryland Historical Trust
West room bracket

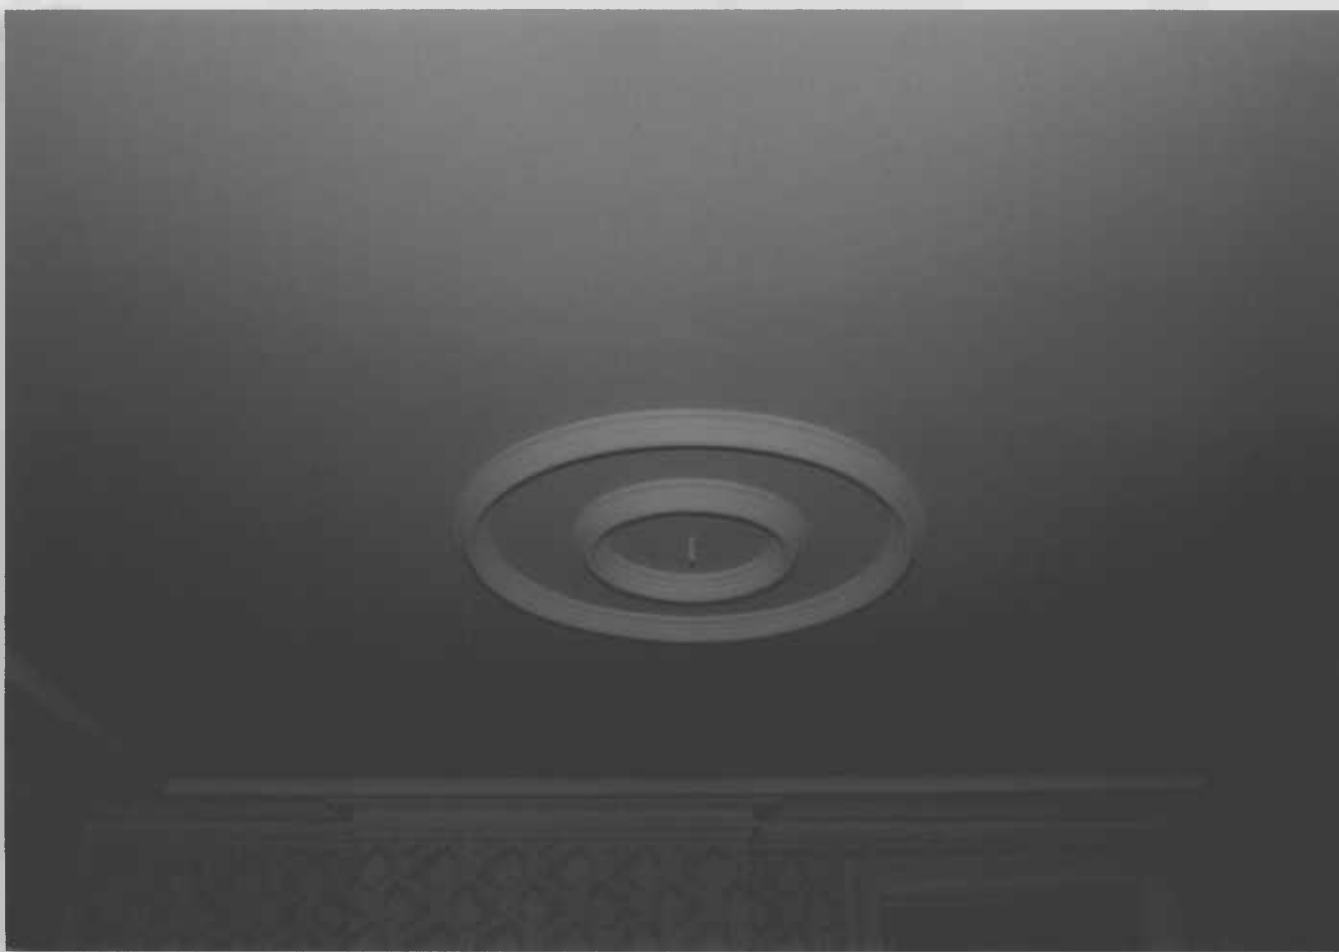
SE room ceiling

The southeast room has an identical floor, baseboard, architrave, windows with panels beneath them, cornice, and ceiling band as is found in the west room. In the center of the ceiling is a circular medallion with the same profile as the bands in the ceiling. It is a smaller circle within a larger circle. The fireplace on the east elevation has a plastered surround and firebox that has been painted red and striped to look like brick. There is a brick hearth. The wood mantel has plain pilasters and frieze and a cavetto bed mould. The shelf is plain. The doors have plain cast iron rim locks.

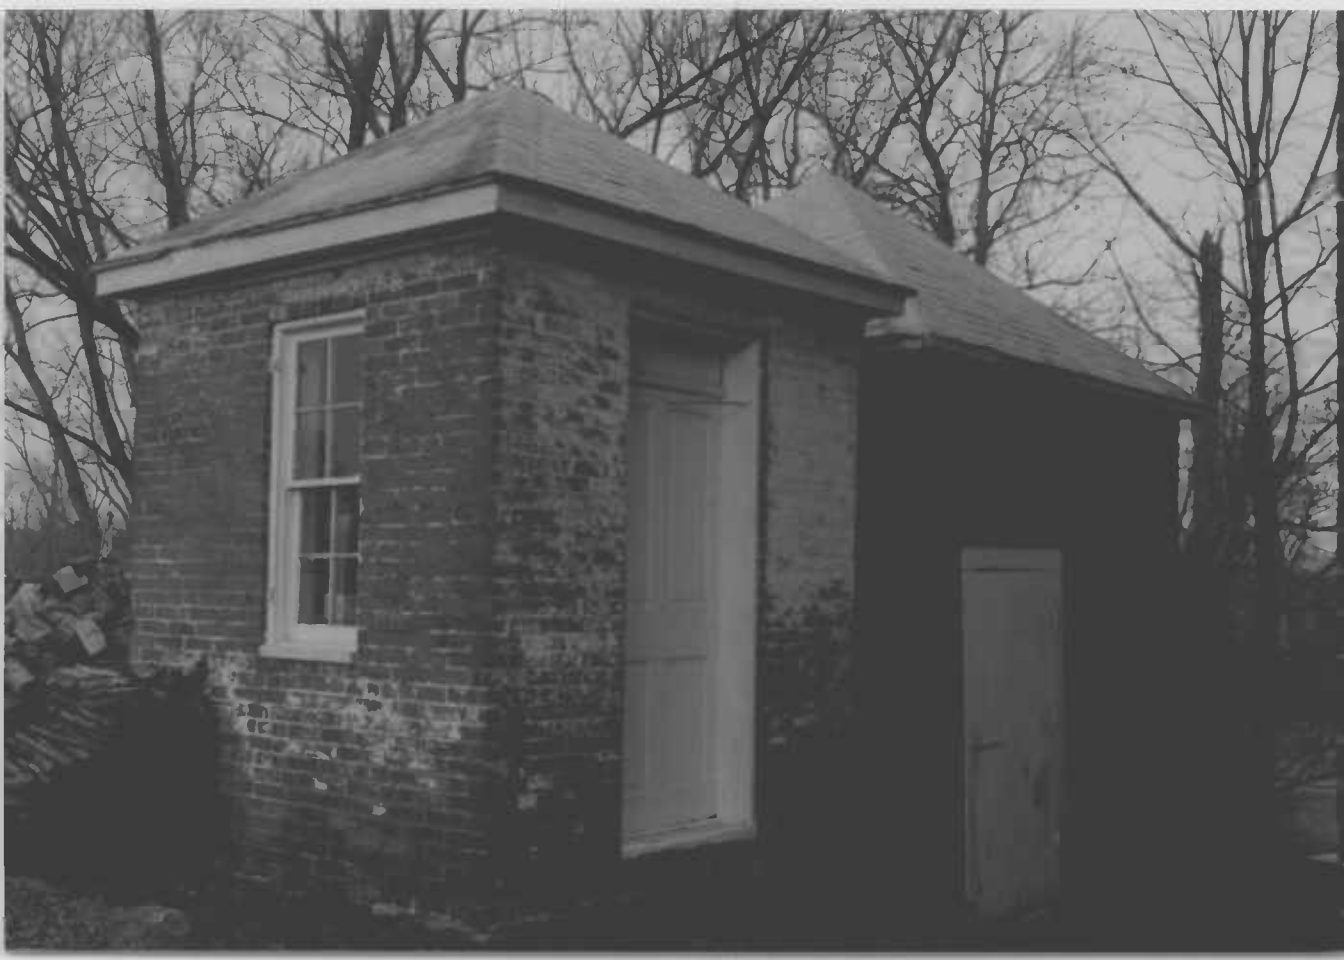
Date: Jan. 1995
Neg. loc. Maryland Historical Trust
Privy & smokehouse - west & south elev.
13/19

About 10 feet north of the house is a privy. It is a one-story, one-bay by one-bay structure with a rubble stone foundation, 4-, 5-, 8-, and 10-to-1 common bond brick, and a hip roof with asphalt shingles. The south elevation has a four-

About 2 feet east of the privy is a smokehouse. It is a one-story, one-bay by one-bay building with a rubble stone foundation, 5-to-1 common bond brick walls, and a hip roof with asphalt shingles and a wood box cornice. The south elevation has a vertical-board door on butt hinges set west of center. There are no openings on the north, east, or west elevations. The interior has exposed brick. There is a concrete floor. The rafters appear to be sawn, and meet at the peak. There is a tree in the center that apparently did not pivot, but the building is large enough that you can walk around the tree. It has three tiers of arms with wrought iron hooks. There is a diagonal brace below each arm, and the ends of the arms are connected to each other by boards.

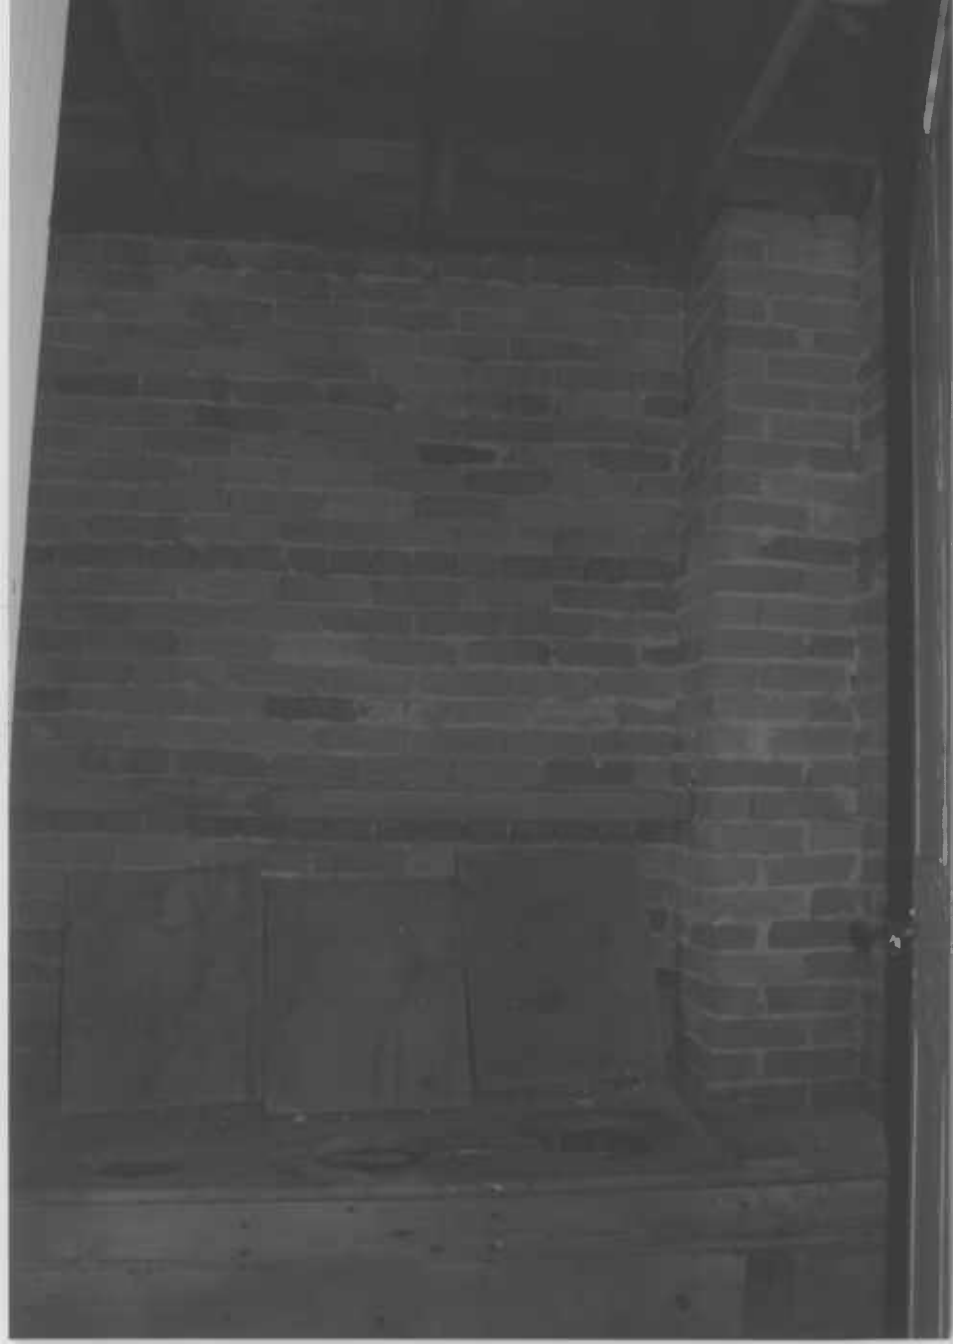
privy interior

panel door with recessed fields and no panel moulds. The frame has a chamfered inner edge and is mitered at the corners. There is a boarded-up transom. The building has a wood box cornice on all four sides. The west elevation has one 4/4 sash. The top sash is fixed in place by the outer stop. There is a wood sill and headers on the lintel. The frame, which is mill sawn, is identical to the door frame. The window has shutter hardware. The east elevation is identical to the west elevation. The north elevation has a small hole in the wall where a brick was left missing near the top of the east corner. This is apparently for ventilation. On the interior, the floor is covered with linoleum. The walls were never plastered, but were always exposed brick. Along the north wall is a wood box with three different-sized holes. There are wood lids on leather hinges that are probably not the original because they are wire nailed. The lids apparently originally had cast iron butt hinges that were broken. There is a brick vent stack in the northeast corner. It has a hole on the west side of the stack, at the base, which is down below the level of the seats, and another on the west side of the stack about 3 feet 6 inches above the floor. The floor joists run north-south. The joists overhead also run north-south. On the east and west ends of the building are short sections of joists that run east-west and are tenoned into mortises in the easternmost and westernmost joists. These tenons are nailed from below with a cut nail. The rafters are about 1½ inches by 2½ inches. In the peak of the hip is a hollow wood box, and the rafters appear to be toenailed to it.

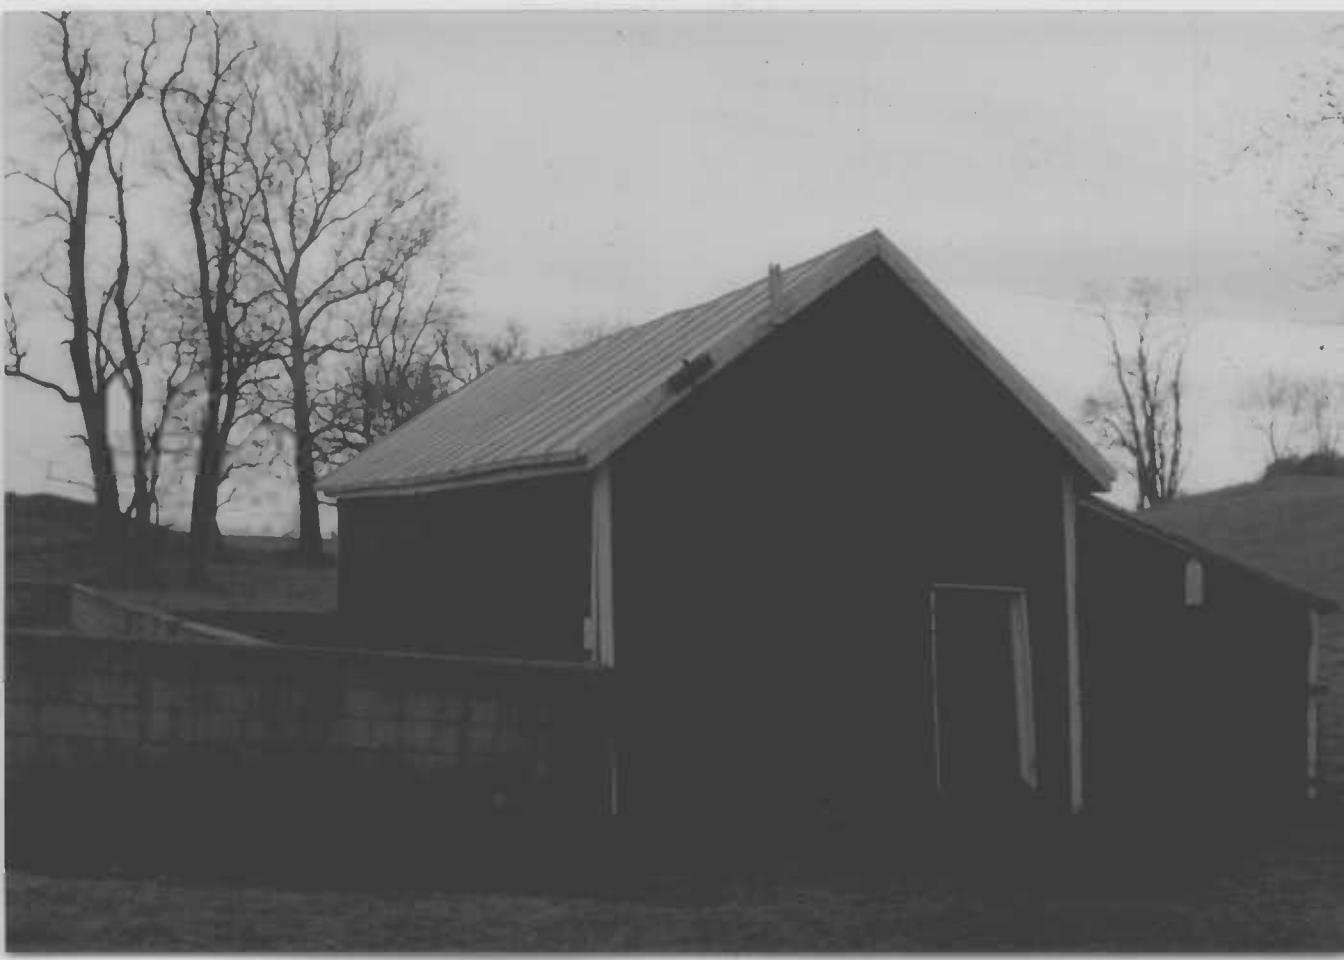
Neg. Loc.: Maryland Historical Trust
Hog pen - east & north elevs.

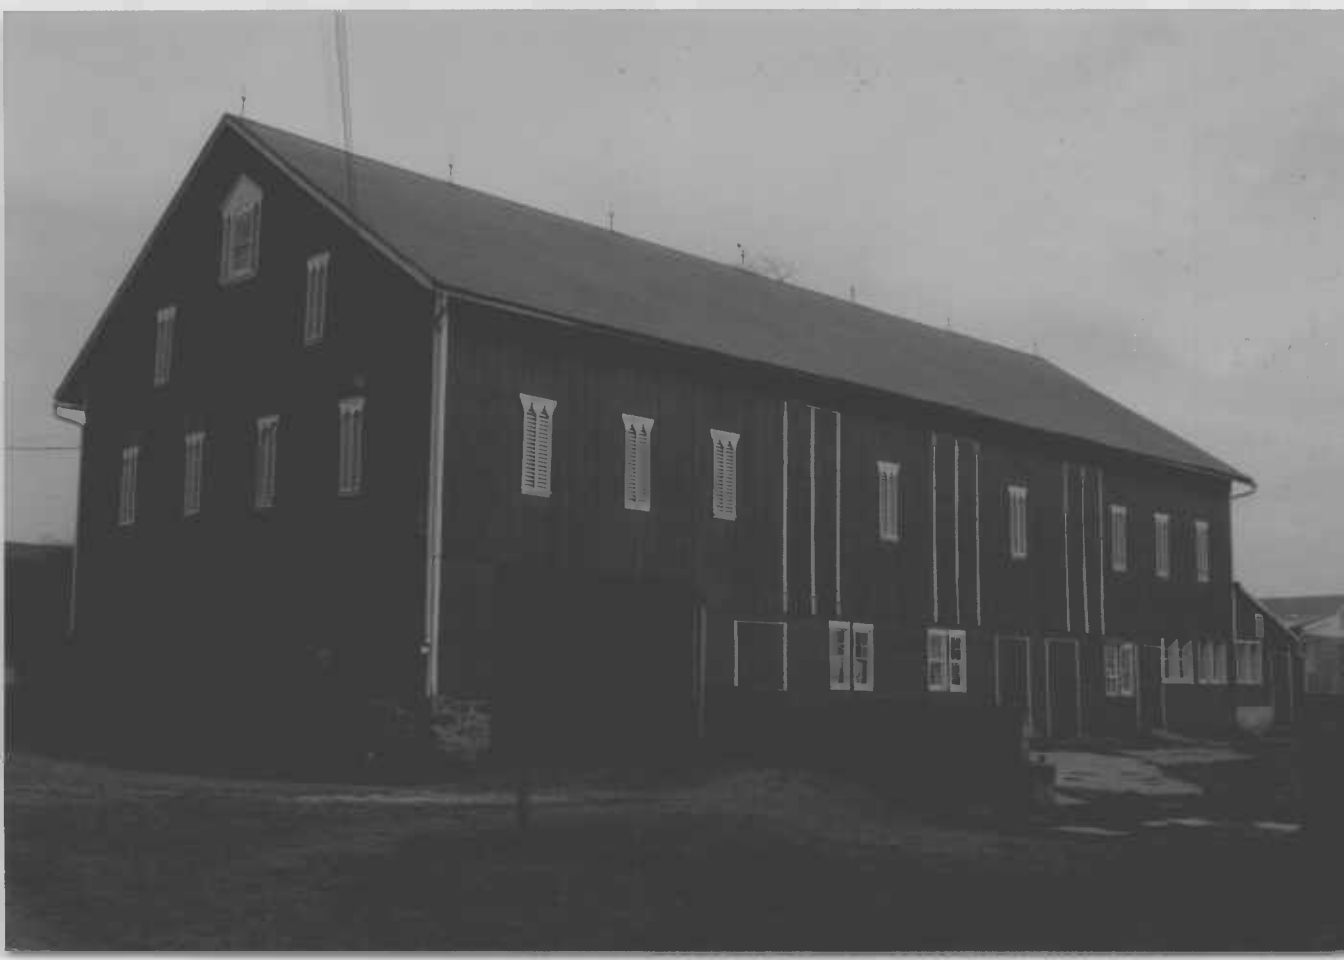
Neg. Loc.: Maryland Historical Trust
Barn- north & west elevs.

About 50 feet east of the hog pen is a bank barn that was rebuilt on an earlier bank barn foundation. The foundation was extended so that there is no longer a cantilevered forebay. The original forebay faced west. The barn has a rubble stone lower story and vertical board upper story, with a gable roof of asphalt shingles that has a north-south ridge. On the west elevation, the lower story has a wagon shed to the north, then a beaded-edge-and-center, vertical-board dutch door on strap hinges with round ends, then a paired 4/4 sash, another paired 4/4 sash, a typical dutch door, another typical dutch door, paired 4/4 sash, a typical door, paired 4/4 sash in a different opening, and paired 4/4 sash in a different opening in the south bay. This bay has German siding. The upper story has three vents at the north end, with double doors over double doors hung on strap hinges like those on the lower story. To the south of this is a vent, double doors over double doors, another vent, more double doors over double doors, and three vents to the south. There is a shed-roof addition to the south, then a CMU milk room attached to the south of this addition. The south elevation upper story has four vents with two vents above in the gable end. The gable peak has a 6/6 sash, with a vent on each side, and pedimented trim. The north elevation has horizontal boards on the lower story, and the upper story is the same as the south elevation. The east elevation has two concrete silos to the south. The silos were installed about 1950. There are three pair of vertical-board wagon doors on rollers in the center, with two vents that have four-light sash at the bottom, set to the south, and two plain vents set to the north. The lower-story north bay is now closed off, but was originally open to gain access to the wagon
